# Manhole Inspection Summary

Manhole # S23A\_\_022MH

Insp Date: **7/30/07 12:00 PM**

**Location** Address: **1314 ALLEY-LANVALE-HARLEM**

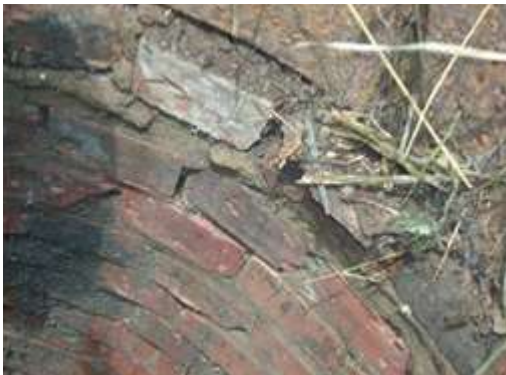
Defect 3

Condition: ☐ Sound ☐ Cracked ☐ Root Intrusion ☐ Loose Brick ☒ **Deteriorated**

DETERIOATION OF CHIMNEY

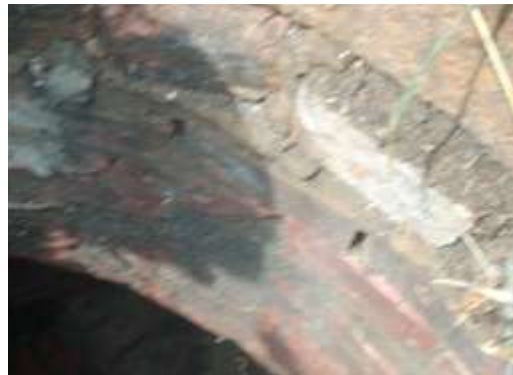
Defect 2

Offset: **1** (in.)

FRAME OFFSET

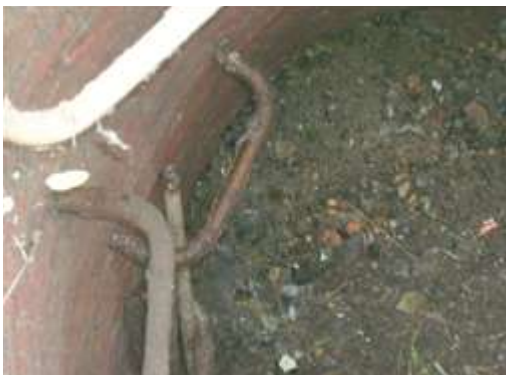
Defect 1

Count: **4** Missing: **0** ☒ **Corroded**

CORRODED STEPS

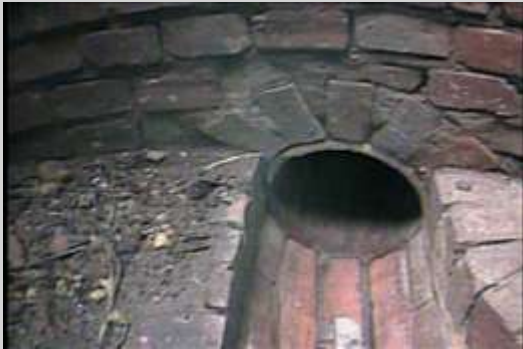
12 O'Clock Outflow

8 in. Circular Gravity Sewer  
Pipe Out @ 12 O'Clock

Pipe Height: **7.2** (in.) Rod and Bar (Angled)  
Pipe Material: **Clay** ☐ Pipe Lined  
Invert Depth: **7.68** (ft.) Flow Characteristics: **Slow**  
Deposits: ☒ None ☐ Mud ☐ Sludge ☐ Debris ☐ Grease  
Silt Depth: (in.) Deposits Extent:  
Infiltration: **None** Pipe Seal Cond: **Sound**

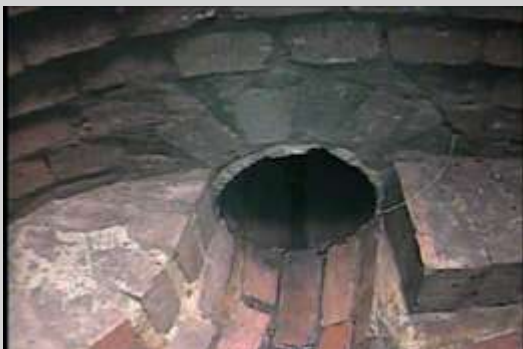
3 O'Clock Inflow

8 in. Circular Gravity Sewer  
Pipe In @ 3 O'Clock

Pipe Height: **8.4** (in.) Rod and Bar (Angled)  
Pipe Material: **Clay** ☐ Pipe Lined  
Invert Depth: **7.61** (ft.) Flow Characteristics: **Slow**  
Deposits: ☒ None ☐ Mud ☐ Sludge ☐ Debris ☐ Grease  
Silt Depth: (in.) Deposits Extent:  
Infiltration: **None** Pipe Seal Cond: **Sound**

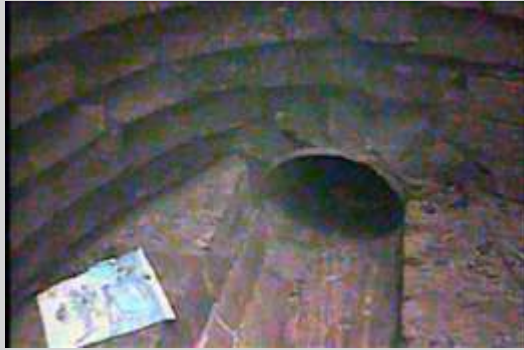
6 O'Clock Inflow

8 in. Circular Gravity Sewer

Pipe In @ 6 O'Clock

Pipe Height: **7.2** (in.) Rod and Bar (Angled)

Infiltration: **None** Pipe Seal Cond: **Sound**
